Banks J, Sheppard M (2016) Heat disinfestation of decorative, high value wooden paneling— an alternative to fumigation. Pp. 119–125. In: Navarro S, Jayas DS, Alagusundaram K, (Eds.) Proceedings of the 10th International Conference on Controlled Atmosphere and Fumigation in Stored Products (CAF2016), CAF Permanent Committee Secretariat, Winnipeg, Canada.

## Heat disinfestation of decorative, high value wooden paneling—an alternative to fumigation

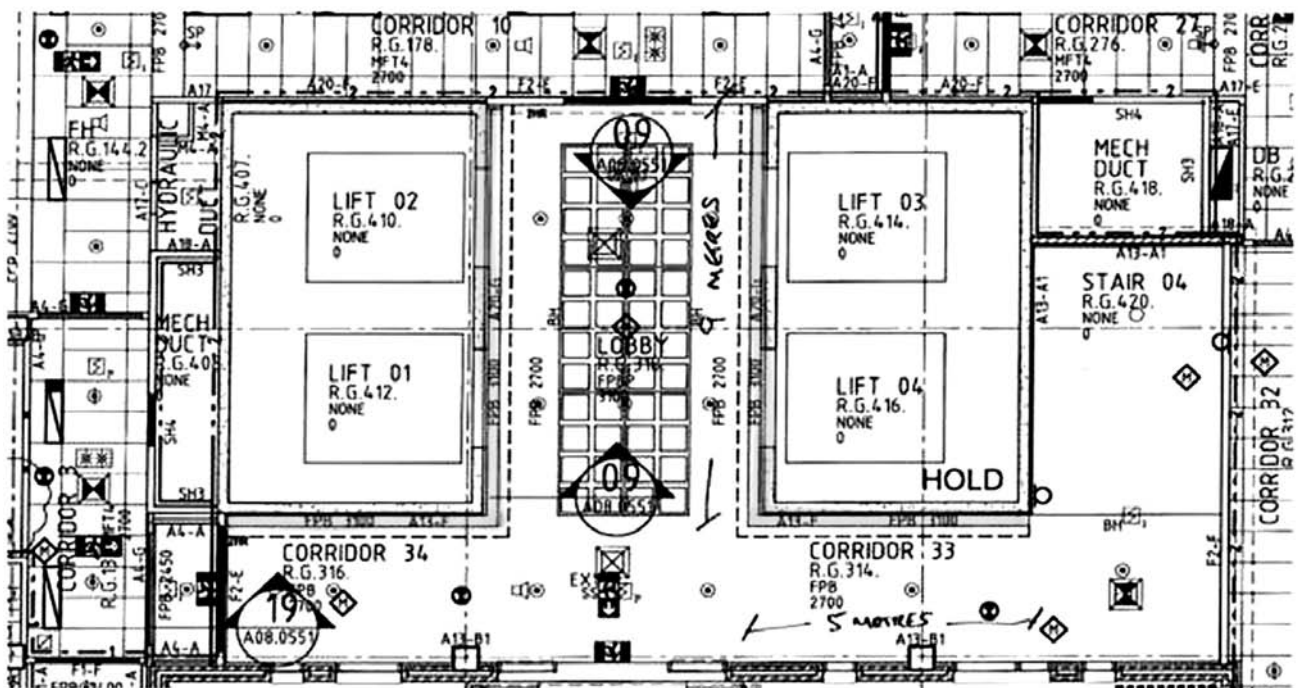
Fig. 1. Floor plan, lift area, ground floor, with position of panelling indicated by green shading

220 mm, and thickness 8 mm. These were located over 4 floors of the building, around the lift well entrances and in some public areas close by (Fig. 1). The largest panels were about 5.5 m<sup>2</sup> and smallest about 0.9 m<sup>2</sup>, with a treated area of 278 m<sup>2</sup> over 76 panels in total.

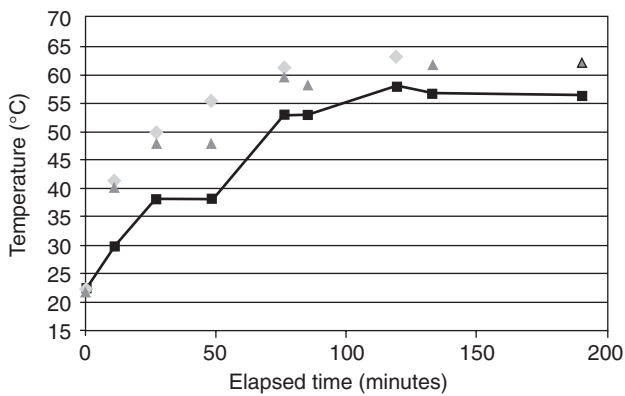
Fig. 3. Heat treatment - Panel 4, Ground floor, showing heat penetration into sheoak wood panelling. Bottom line (pink) shows rise in temperature to >56°C behind the panelling while surface points (data points without line) indicate >60°C.

Observations from an embedded thermocouple supported the assumption that heating and maintaining the outer surface to >60°C led to adequate heat dosage at the rear of the panel of >56°C for an adequate period (Fig. 4).
