## THE PRACTICAL SIDE OF SILO SEALING

W (BILL) WOODCOCK

WOODKON Pty. Ltd., 140 Great Northern Highway, Middle Swan  
6056, WESTERN AUSTRALIA

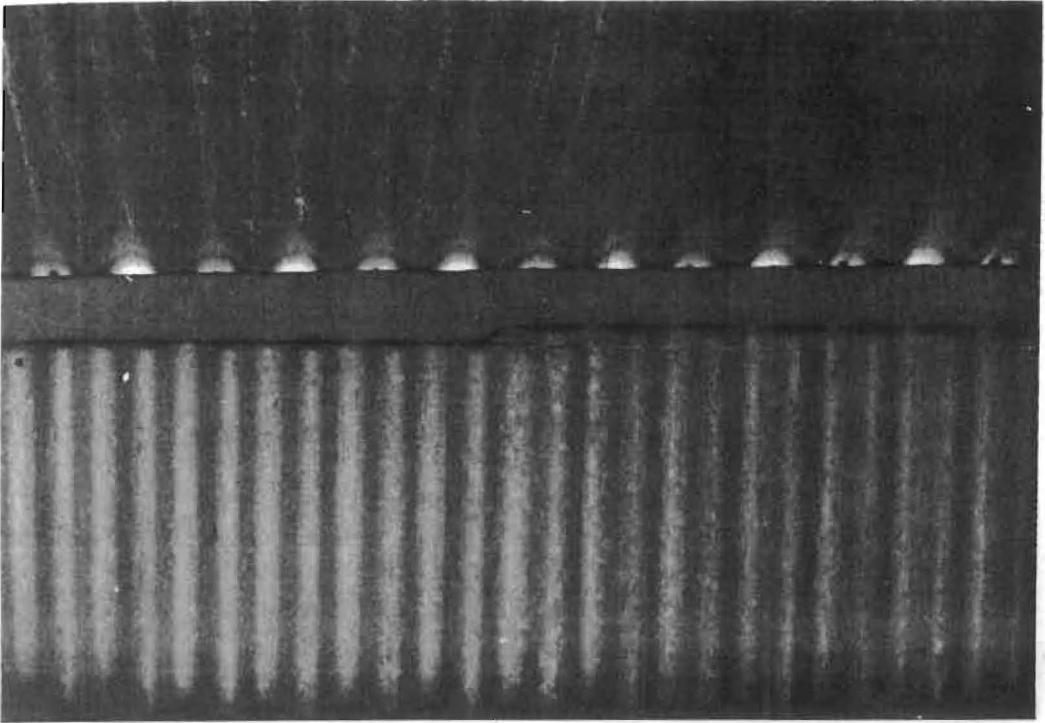
Fig. 2 Internal view of the wall-to-roof region.

The lap joints in the metal cladding and at the gable ends are sometimes foamed with polyurethane. This reduces total time for sealing and usage of material on external surfaces. The join between the curtain wall and roof cladding (Fig. 2) is foamed. It is recommended that the foam extend 20 cm down the wall and 20 cm onto the roof cladding to strengthen the area and reduce movement there.

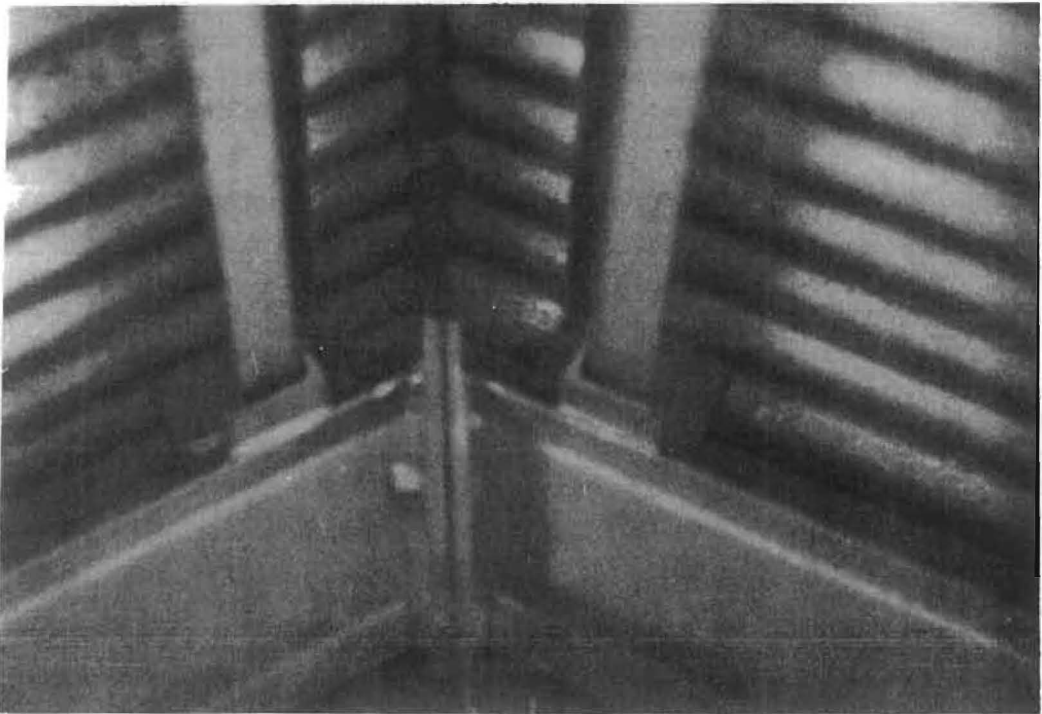
Fig. 3 Internal view of the ridge line of the roof in the penthouse.

The ridge line of the roof (Fig. 3) is filled with polyurethane foam to a depth of 10cm, extending between the top purlins on each side. This treatment not only seals but strengthens the region. The ridge is walked on frequently during the sealing operation.

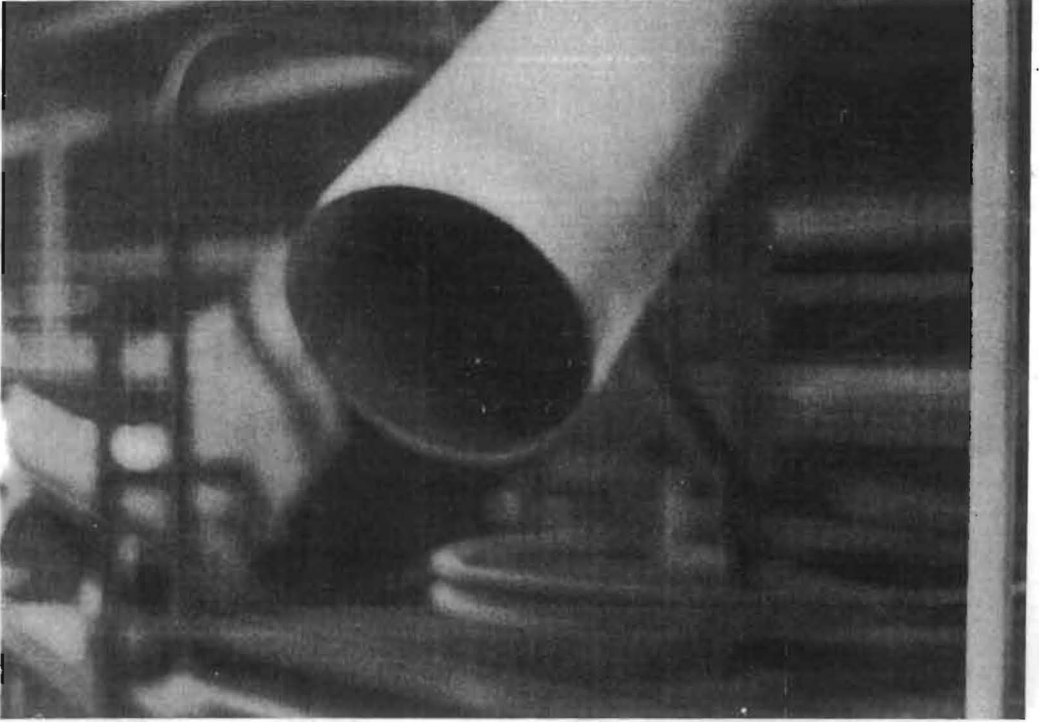
Fig. 4 Distribution chute for grain at the top of the storage.

The grain distribution chute (Fig. 4) is sealed by taping a heavy duty plastic sheet or bag over the end. The chain lines used for manual operation of the valve from outside are sealed with silicone rubber, butyl mastic or acrylic sealant from a cartridge gun at the point where the chains go through the penthouse wall.

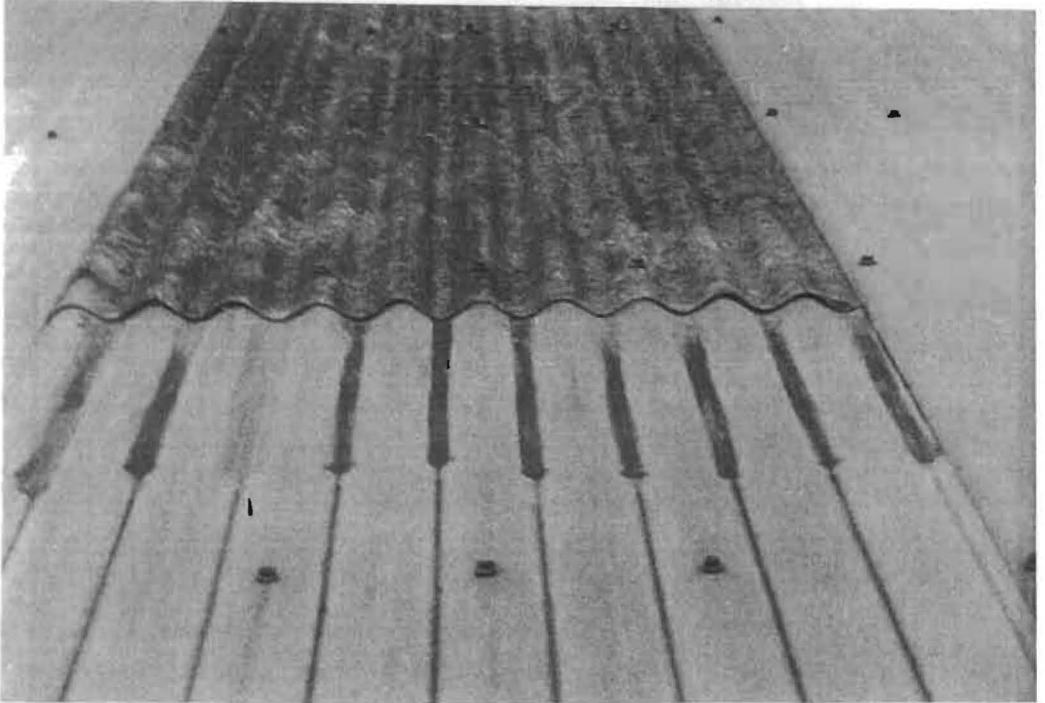
a problem. These are caused by incorrect fitting, rough handling and fixing with screws or bolts or damage from workmen standing on the skylight.

Fig. 5 Region of the roof where the skylight overlaps with the metal roof cladding.

Skylights should be fixed down with pop-rivets. A cloth, fibreglass or bitumen tape should be applied over the edges of the skylight to reinforce the membrane applied in this weak area (Fig. 5). Skylights may deteriorate badly under the intense sunlight of Western Australia. In some instances they must be replaced. Sometimes, it may be possible to repair them using a polyester resin coating to rebond the fibres. A heat reflectant coating over the pannel eliminates further deterioration. Hairline cracks in skylights are

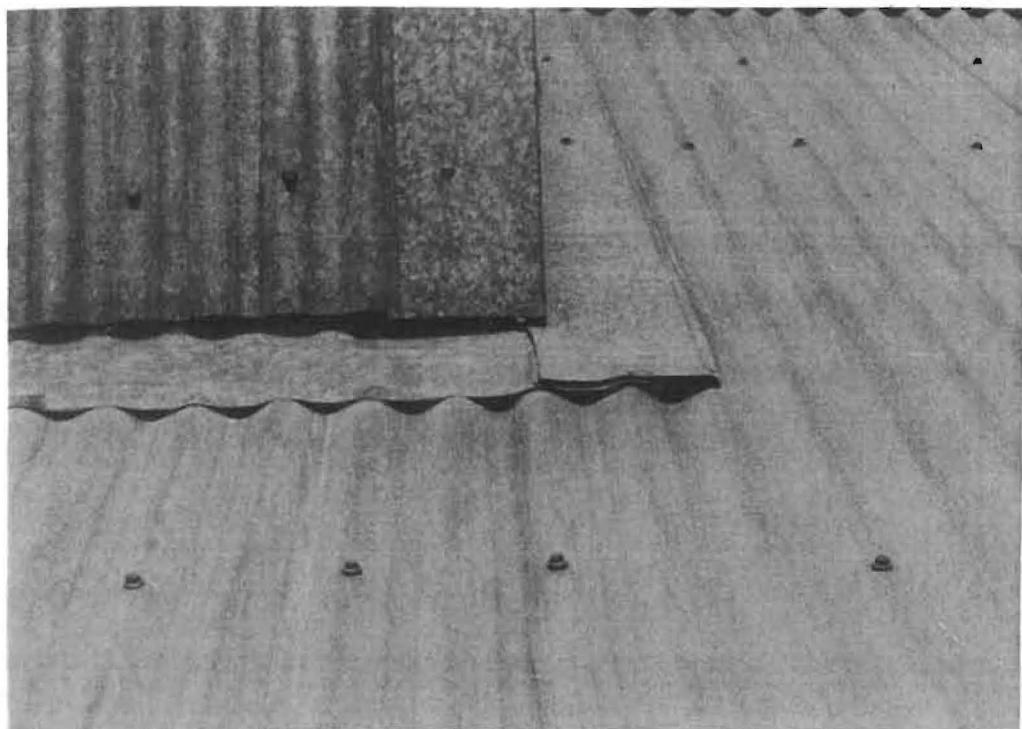
Fig. 6 The join between the penthouse and the storage roof.

The region where the penthouse fits into the main roof is a problem (Fig. 6). The full foaming internally eliminates most leaks. However the penthouse must also be sealed externally here (e.g. with a flexible membrane sealant with bitumen or cloth tape reinforcement) to prevent rain getting behind the foam inside.

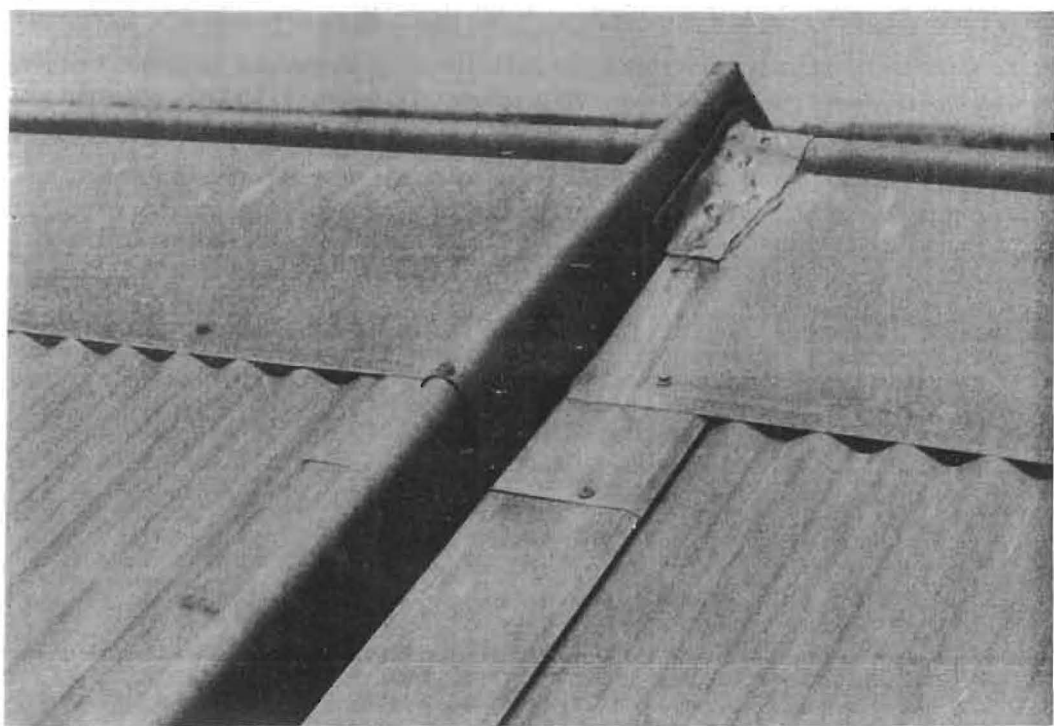
Fig. 7 An expansion joint, at the place where it joins the roof ridge.

Almost all the thermal movement in a storage takes place under the expansion joint cappings (Fig. 7) This makes the region particularly difficult to seal. Flexible polyurethane foam ( $0.5 \text{ kg m}^{-3}$  density) can be sprayed into the joint from below and a flexible membrane (e.g. a styrene-acrylic emulsion system) applied with reinforcement over the top of the joint. The foam provides a very good seal by itself.

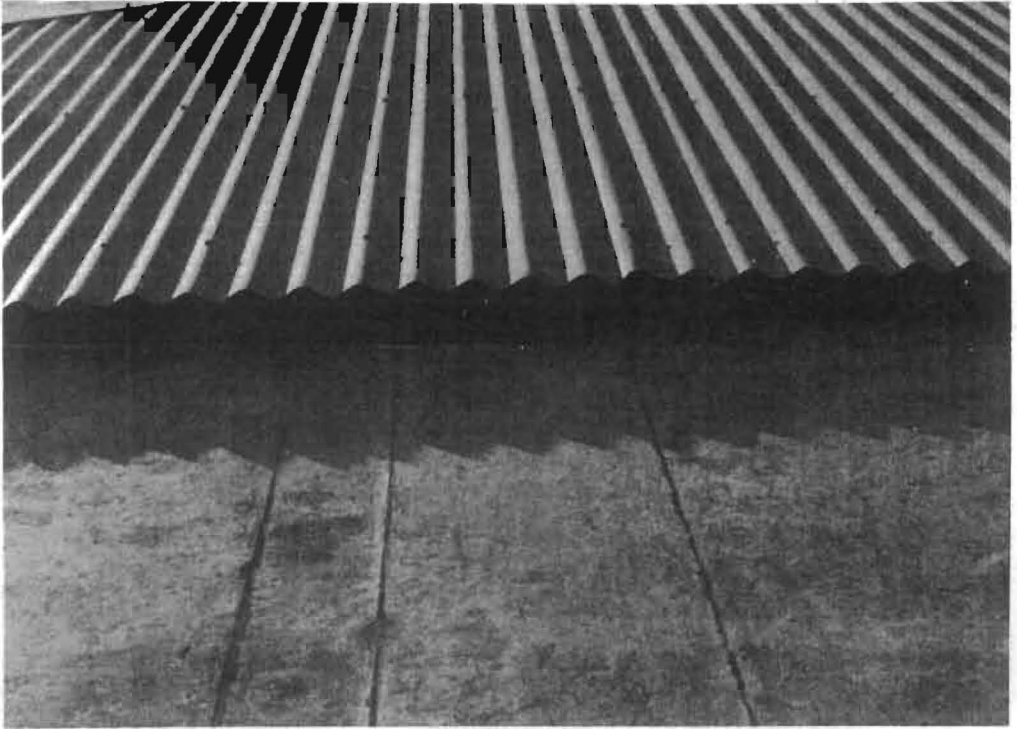
Fig. 8 The region of the gable end where the wall cladding overhangs the top of the concrete wall. Viewed from below.

The gable ends can be sealed using a flexible spray-applied membrane externally. Unfortunately it may be necessary to apply several coats of sealant to achieve specified thickness because thick films tend to run on the vertical surface. The seams in the gable end may be sealed internally with polyurethane. In this case a thinner external coating is acceptable. The place where the metal cladding of the upper part of the gable end meets the concrete wall (Fig. 8) is filled with polyurethane foam completely. This removes a haven for birds, moths, spiders etc. and prevents wind damage to the sealing membranes. If this region is not filled it is possible for high winds to blow up into this region causing excessive movement of the cladding.

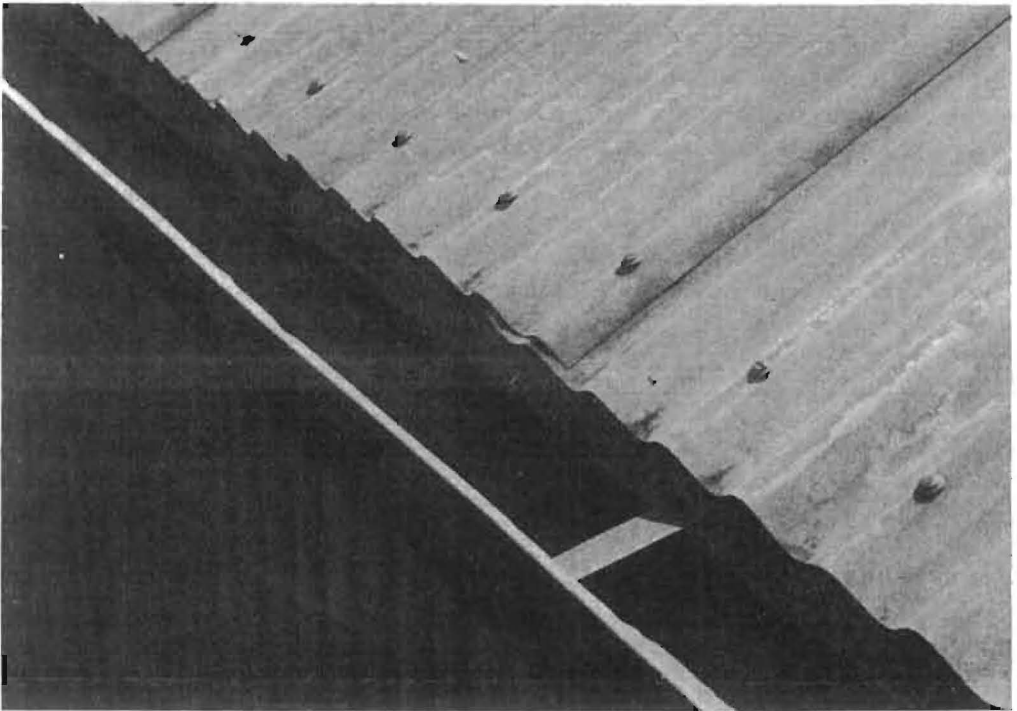
The region where the roof cladding joins the walls at the gutter line is a critical area for sealing and many of the problems encountered occur in this region (Fig. 9). Two systems of sealing have been used successfully there. After removal of the gutters, each lap joint is unbolted, the top sheet

Fig. 9 The lower ends of the roof sheeting at the gutter line.

is lifted and a piece of felt or reinforcing material, dipped in the membrane sealer used (eg. an acrylic), is placed between the two sheets. The cladding is then bolted down again. Alternatively bitumen sealing tape can be used in place of the felt. The tape should be at least 2mm thick. It should be applied so that it seals between the sheets for at least 15cm along the join and for 15cm across the sheets at the open ends. This sealing should be carried out before any polyurethane foam is applied to the region internally.
